## **AN OVERVIEW OF RANJIT SAGAR DAM PROJECT, GURDASPUR DISTRICT, PUNJAB**

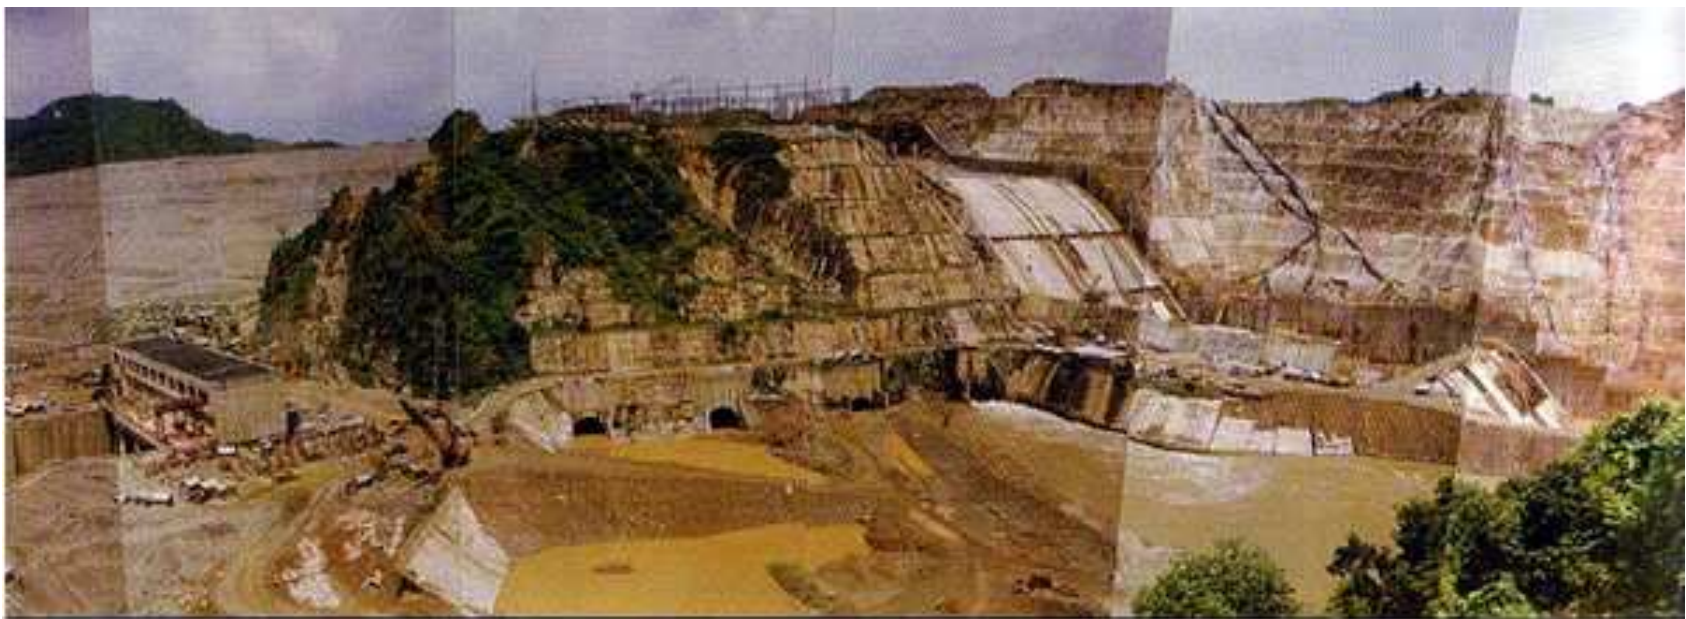
**Photo 1: A Panoramic and composite view of Ranjit Sagar Dam Project in final stages of construction (view from right bank of Ravi River)**

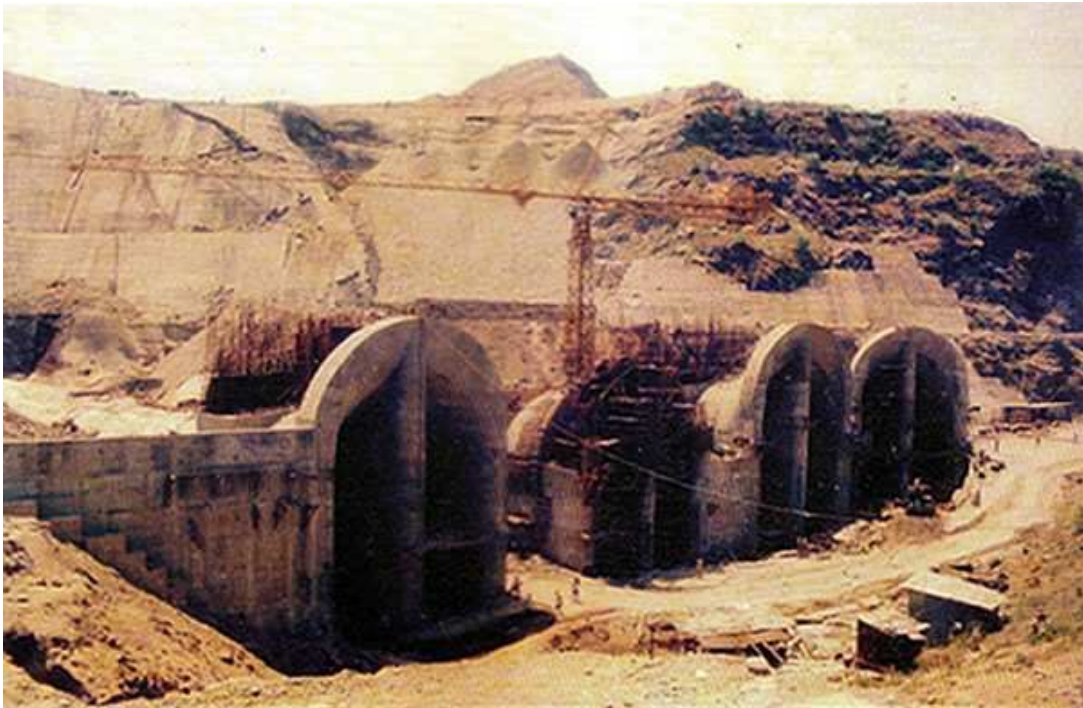
**Photo 2: Construction of False Structural Portals at Inlets of Diversion Tunnels in Progress**

The Ravi waters, during the diversion stage, were routed through four, 12m diameter circular tunnels located in the left abutment hill and excavated through alternating bands of sandstone and claystone / siltstone. After completion of the project, two of the diversion tunnels, P-1 and P-2, are being used as power tunnels to feed four units of 150 × 4 MW capacity surface power house. The remaining two tunnels, T-1 and T-2, serve as irrigation outlets to fulfill the commitments of the downstream command areas.

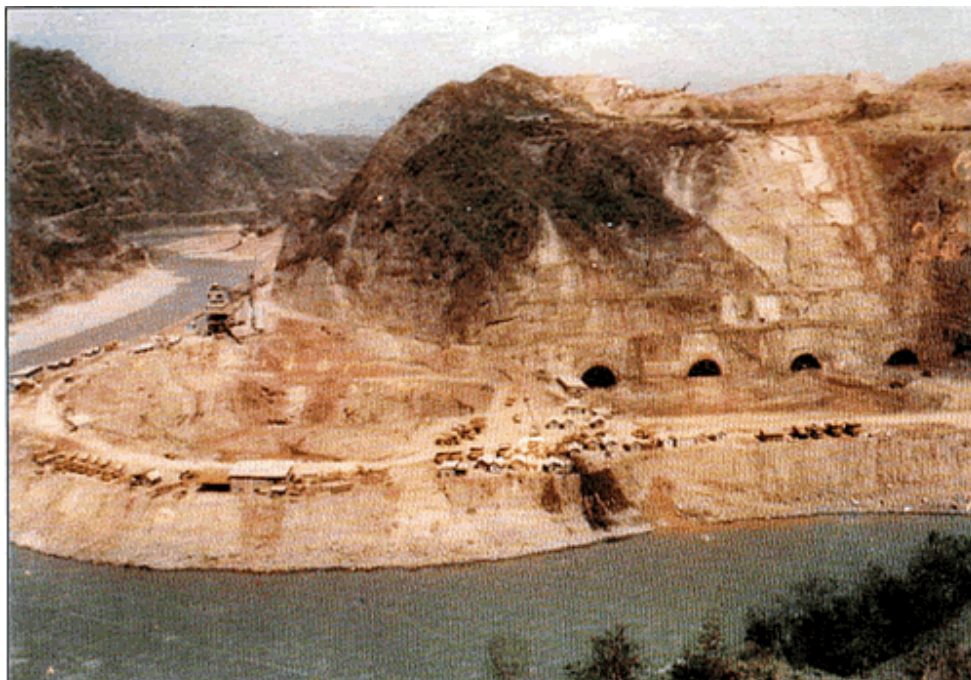
**Photo 3: Panoramic view from right bank of Ravi looking upstream ( at the beginning of construction of project), showing Outlet Portals of the Diversion Tunnel and excavation of the Power House pit. The dam axis lies just upstream of Power House location in the left background across Ravi**

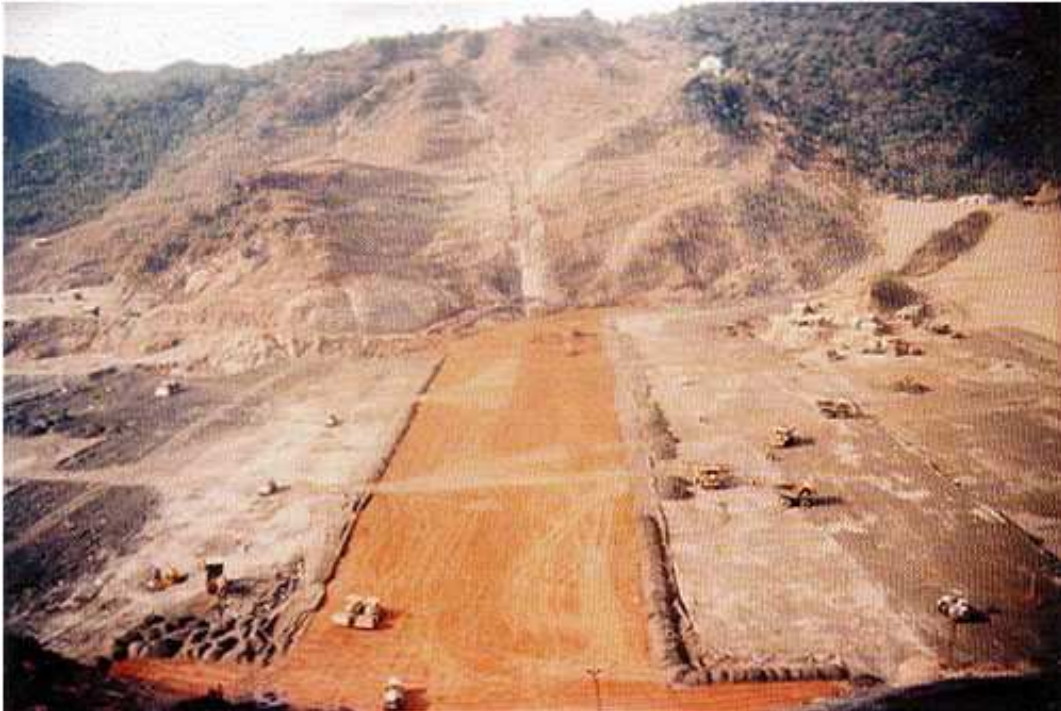
**Photo 4: View of Dam looking towards right abutment at higher elevation. Impervious Clay Core flanked by upstream (towards right) and downstream (towards left). Filters and pervious Shell Zones compacted by rollers**

Foundation grade geological mapping of the clay core base on scale 1: 200 was carried out and the geological features have been recorded for future reference. During every stage of construction of the dam, geological advice has been provided to ensure the safety of the structure. The clay core base has been placed from elevation  $\pm 392$  m to elevation  $\pm 400$  m. This was found to be generally 3 to 6m higher than the anticipated levels on the basis of subsurface exploration data. During the course of mapping, loose, weathered and open jointed rock in the core base foundation was removed prior to clay placement. The area grouting of core base area of Dam was done before placement of clay. The 15m deep holes for area grouting were drilled in hexagonal pattern at 6m c/c. The depth of the area grouting was kept 15m up to El. 461m, and above 461m the depth was reduced to 10m. The average grout intake in the holes for area grouting was 18 bags per hole in general, except in some holes in Sandstone Bands where maximum grout intake in one hole was reported to be 283 bags. Also, a single row, about 60m deep, grout curtain has been created at a distance of 10m on the upstream side of foundation gallery.

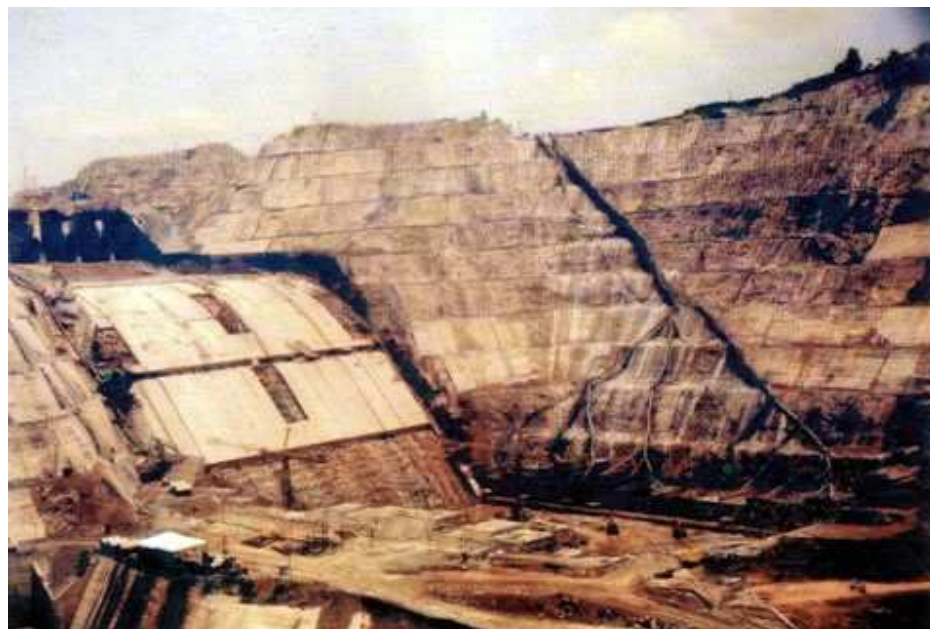
**Photo 5: Left flank Spillway construction under progress. Hill-cut benches towards left side, shotcreted and covered with concrete claddings are also seen.**

The 133m wide and 547.55m long spillway structure of RS Dam consists of ogee shaped crest at elevation 512m with seven radial gates followed by spillway chute with 1:30 gradient and steep 1:1 plunge slope joining with energy dissipation arrangement. The energy dissipation arrangement consists of a combination of stilling basin at elevation 402m, ogee weir and a roller bucket at elevation 385m. The construction of the Spillway structure was a challenging task as it involved huge rock cutting on the left side. The foundation mapping revealed that the actual geological conditions were similar to those foreseen during the investigation stage. Stability problems were visualized in excavation of the plunge slope and left flank of the spillway and suitable measures were suggested to stabilize them.

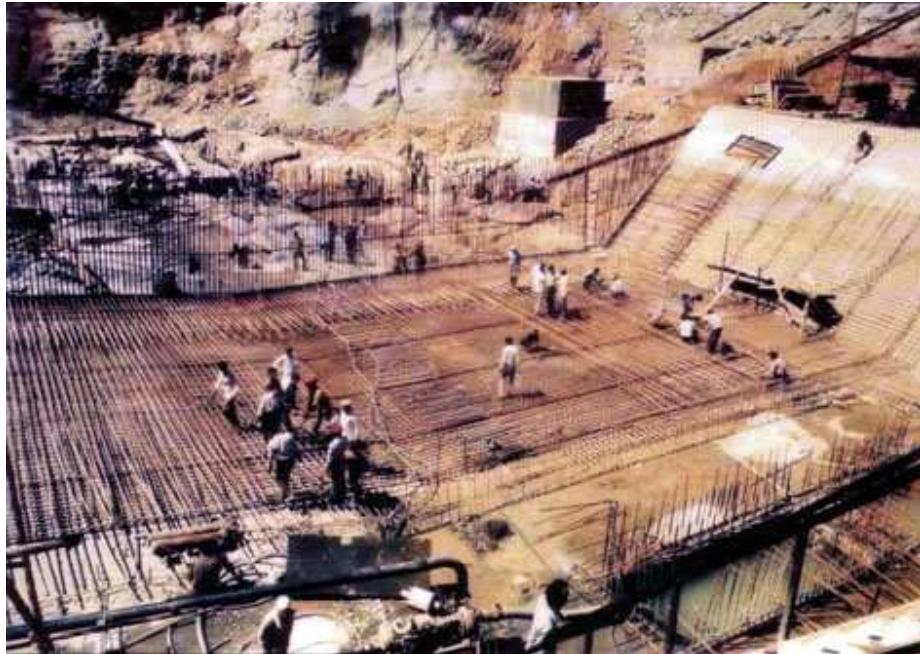
**Photo 6: Power House construction under progress. Foundation being designed as raft foundation over rocks of varying competency**

The Power House consisting of four generating units of 150 MW each, has an installed capacity to produce 600 MW and has been located 360m downstream of the dam axis, on the left bank of river Ravi. It's long axis is aligned parallel to the strike of the rock bands, so that the upstream and downstream ends of the powerhouse are located on sandstone band 40B and 41B respectively. The powerhouse foundation grade is designed at elevations varying from 387.57m to 389.27m, which is about 14.80m to 16.5m below the river bed level. The foundation had 1:1 slope in downstream direction.
